5. High and Moderate Flood Risk Communities

5.1 Town of Falher

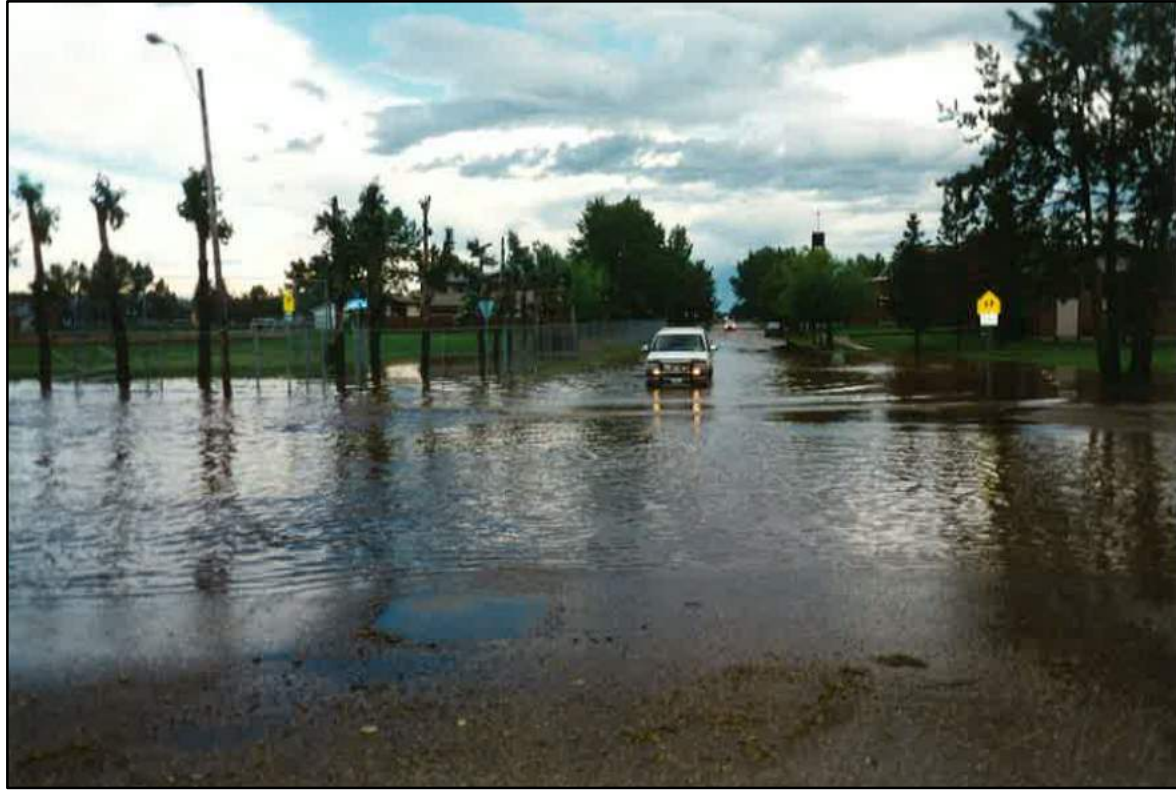
Historical flooding in the Town of Falher

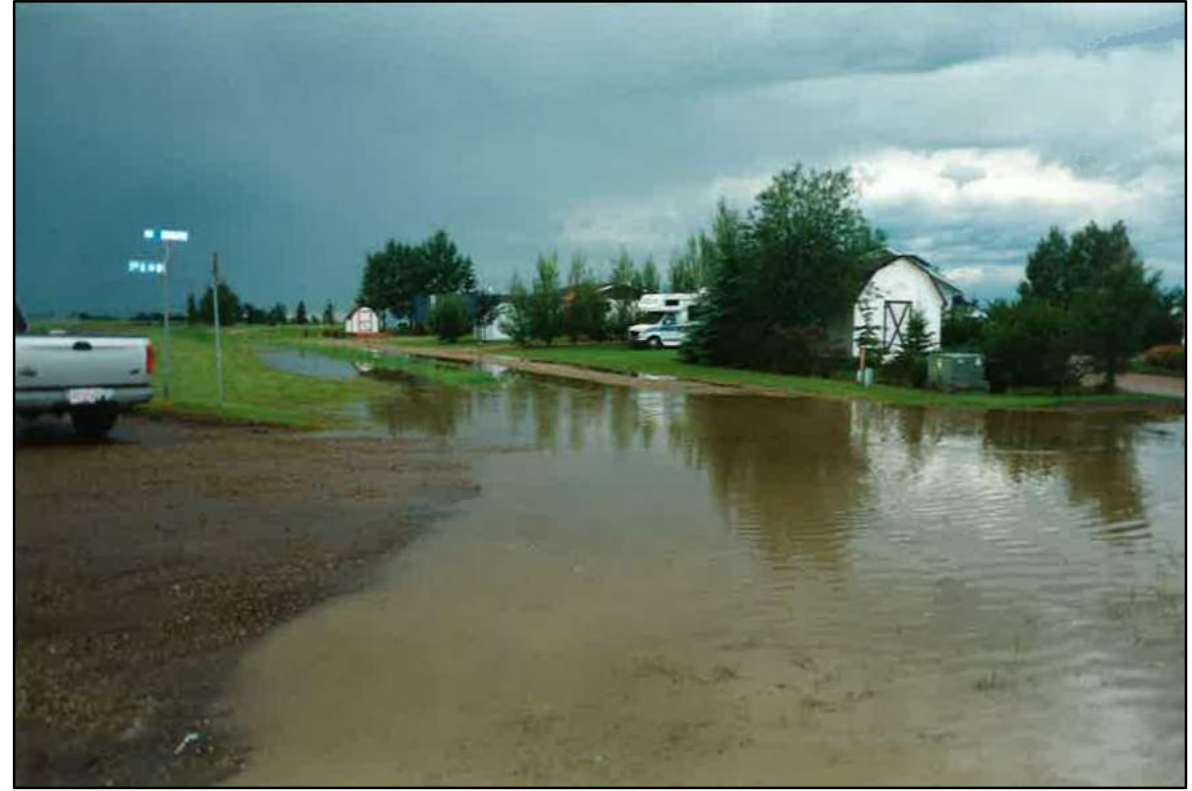
Historical flooding in the Town of Falher

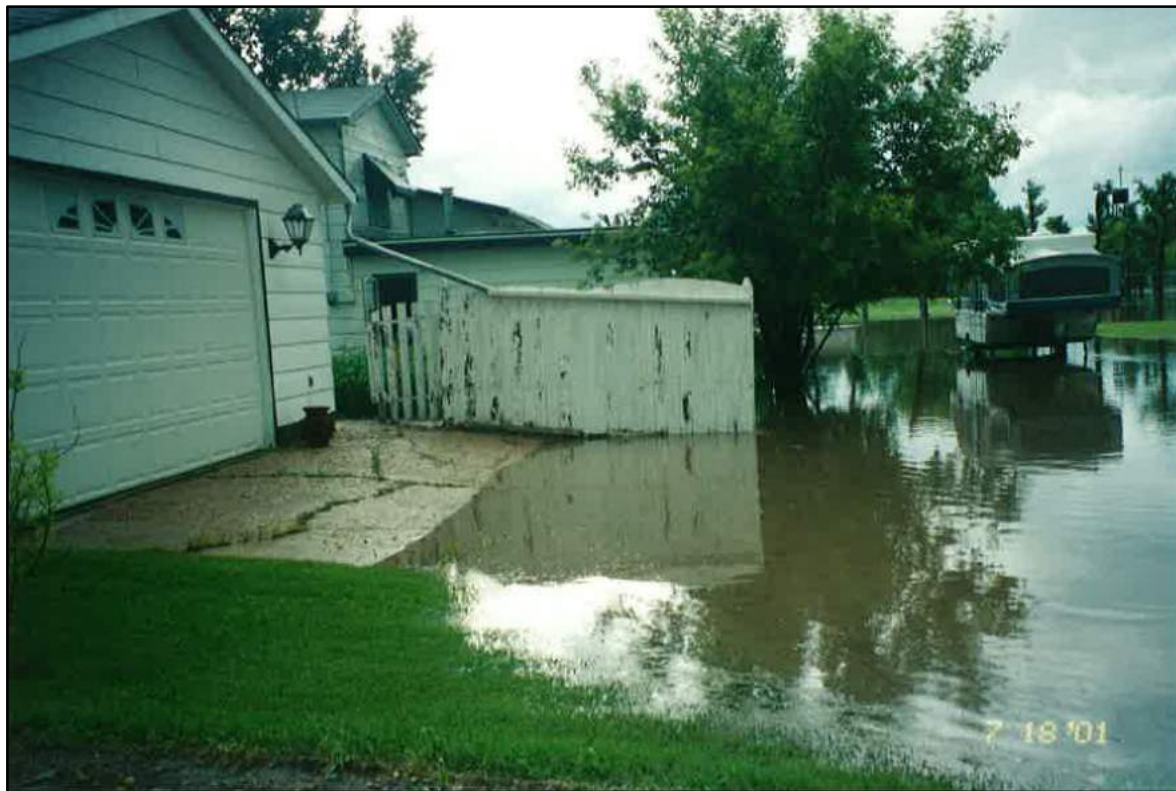
Historical flooding in the Town of Falher, Photo taken July 18, 2001.

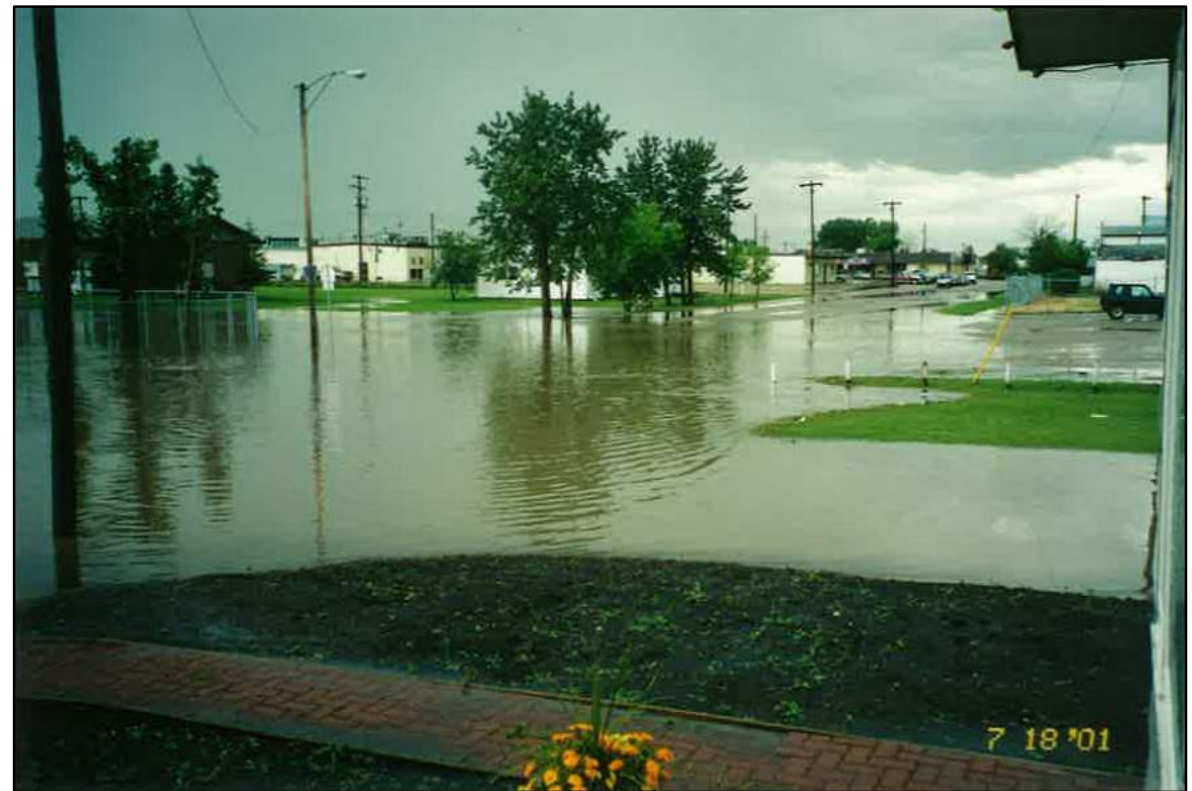
Historical flooding in the Town of Falher. Photo taken July 18, 2001.

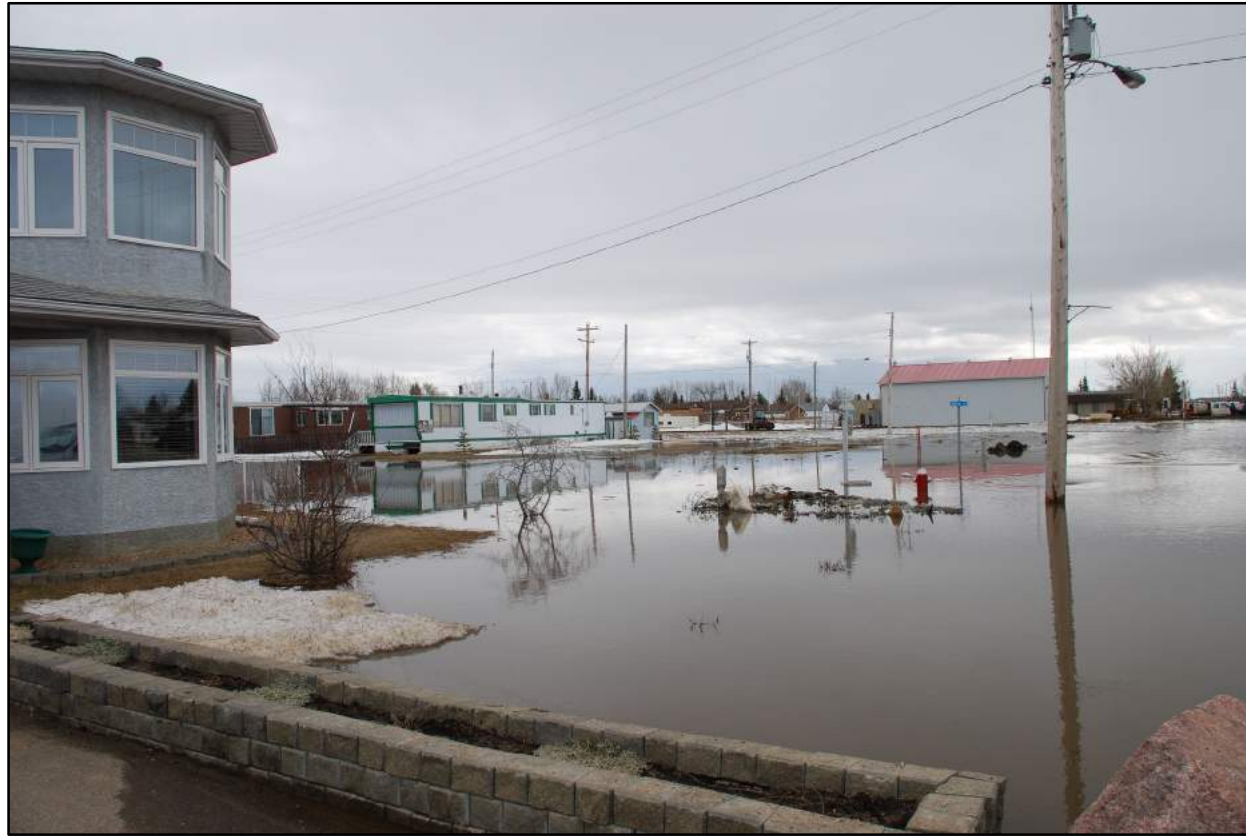
Flooding in Donnelly. Photo taken April 17, 2007.

AECOM recommends that the Village annually inspects the culverts which caused the 2007 flooding event, and insure that there are no debris or ice blockages. This maintenance practice should provide a cost effective way of preventing overland flooding in the Village of Donnelly, similar to the 2007 event.

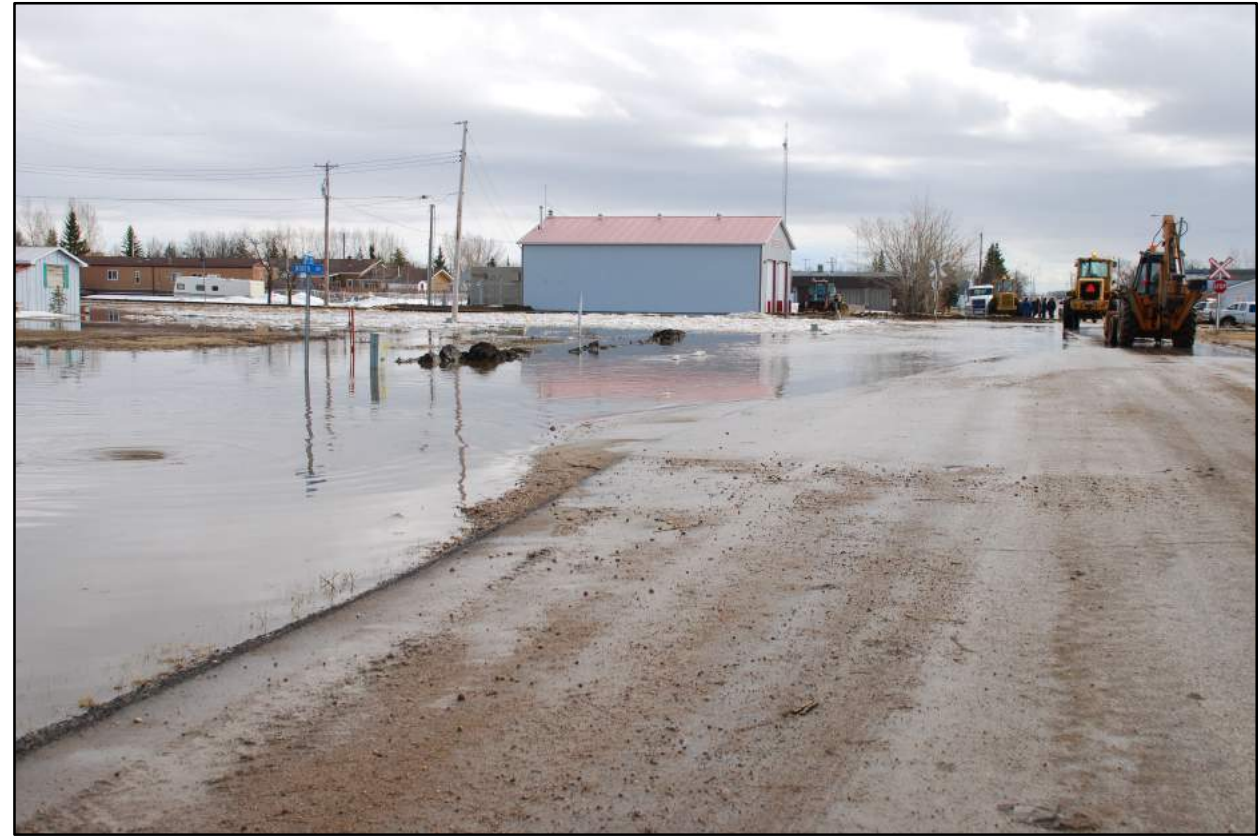
Flooding in Donnelly. Photo taken April 17, 2007.

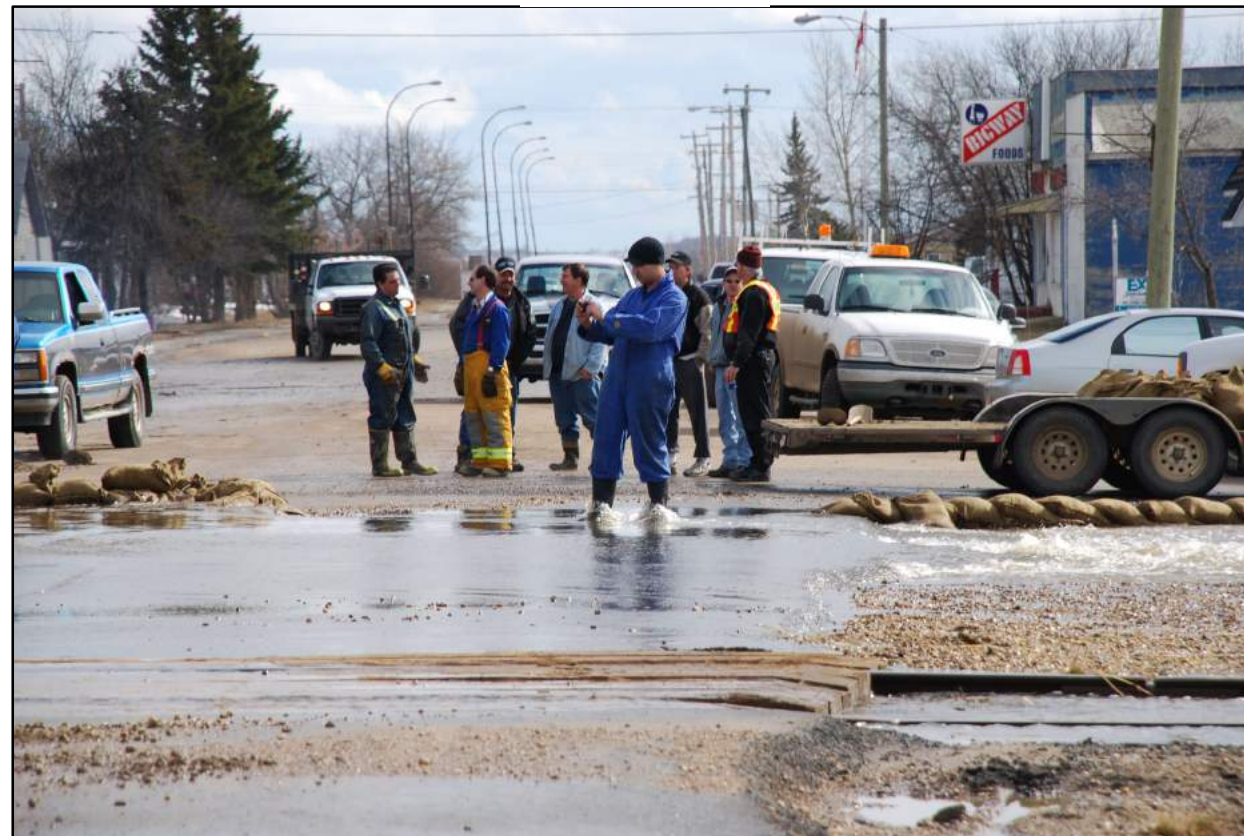
Flooding in Donnelly. Photo taken April 17, 2007.

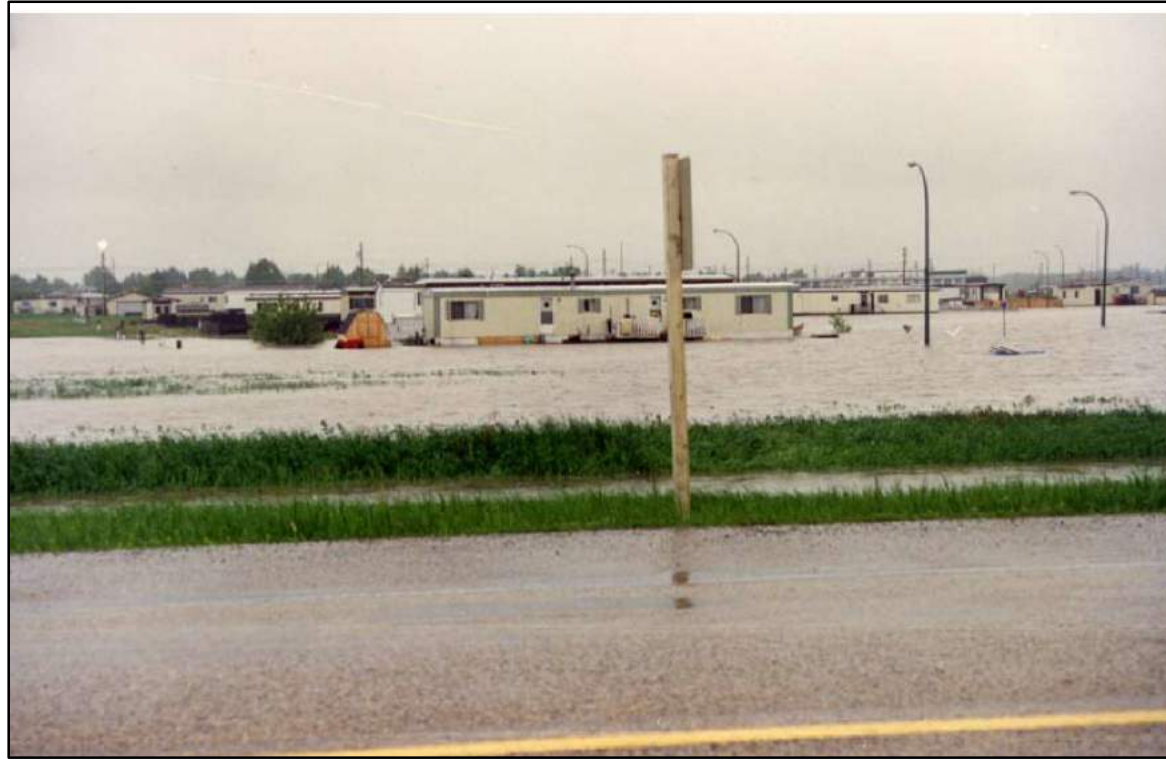
June 1990 flood. Looking west toward the Village of Rycroft from Highway 2. Photo provided by the Village of Rycroft for previous study by AECOM.

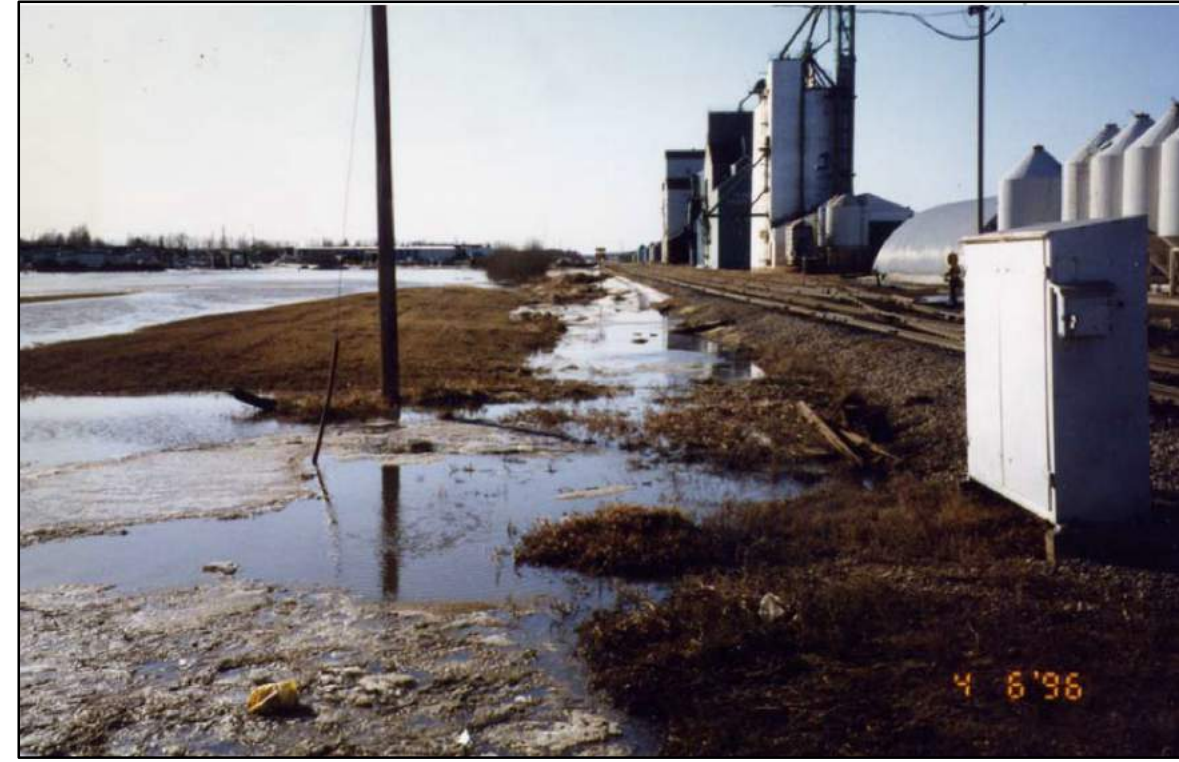
April 1996 flood. Looking west along the south side of the railway line from Highway 2. Photo provided by the Village of Rycroft from a previous study by AECOM.

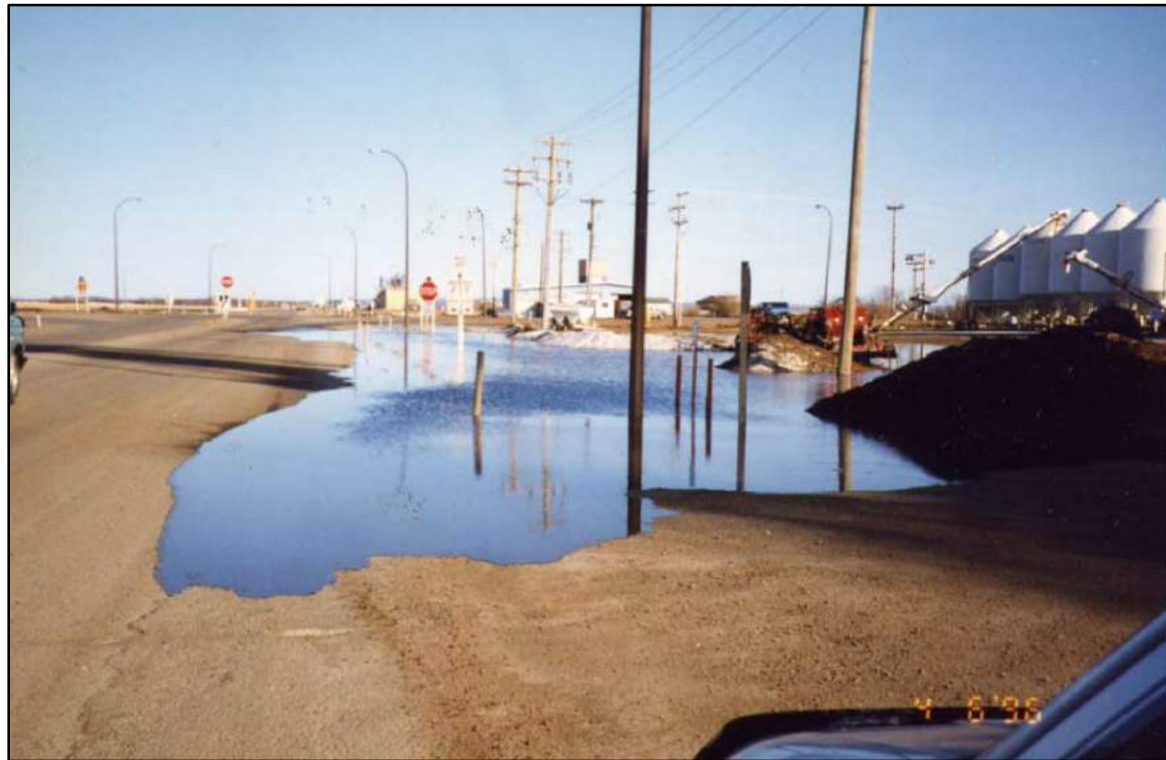
April 1996 flood. Start of overtopping of Hwy 49 near Hwy 2. Photo provided by the Village of Rycroft for a previous study by AECOM.

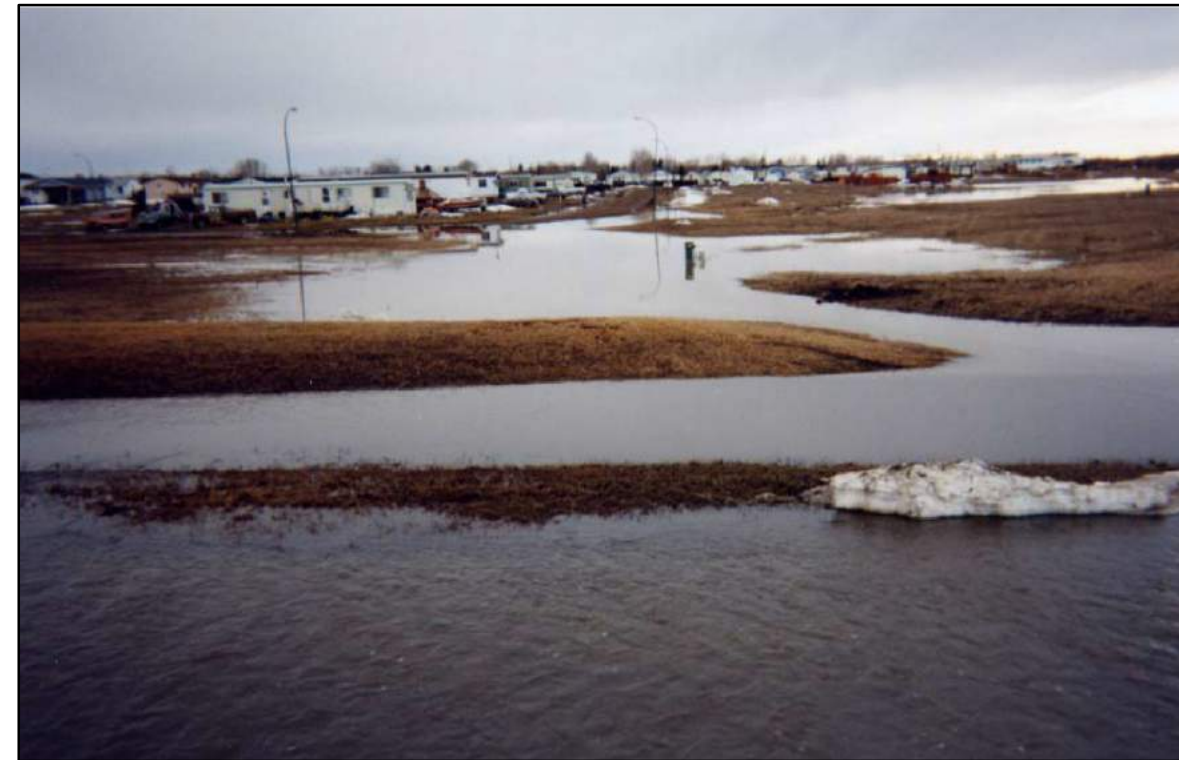
April 1997 flood. Flooding in Rycroft immediately west of Highway 2. Photo provided by the Village of Rycroft for a previous study by AECOM.
