Appendix A

Stakeholder Issues Map ID Table

Stakeholder Identified Flood Risk Summary Table

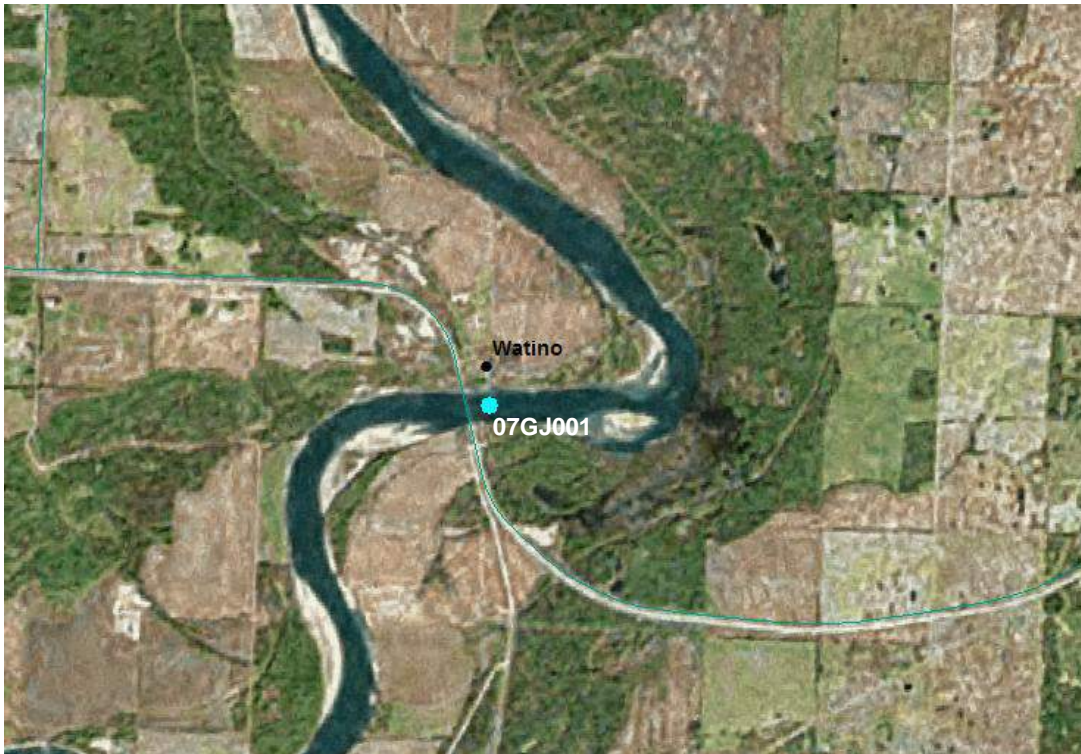
Figure 1-1: Station Location

Historical flow data obtained from the Water Survey Canada (WSC) Stream Gauge Station 07GJ001 (Smoky River at Watino) was used for the Flood Frequency Analysis. The station location is shown in Figure 1-1.

The total contributing catchment area to Station 07GJ001 is 50,300 km². The effective area is reported as 49,600 km². Table 2-1 details the maximum annual flow data extracted from the WSC gauging station 07GJ001.

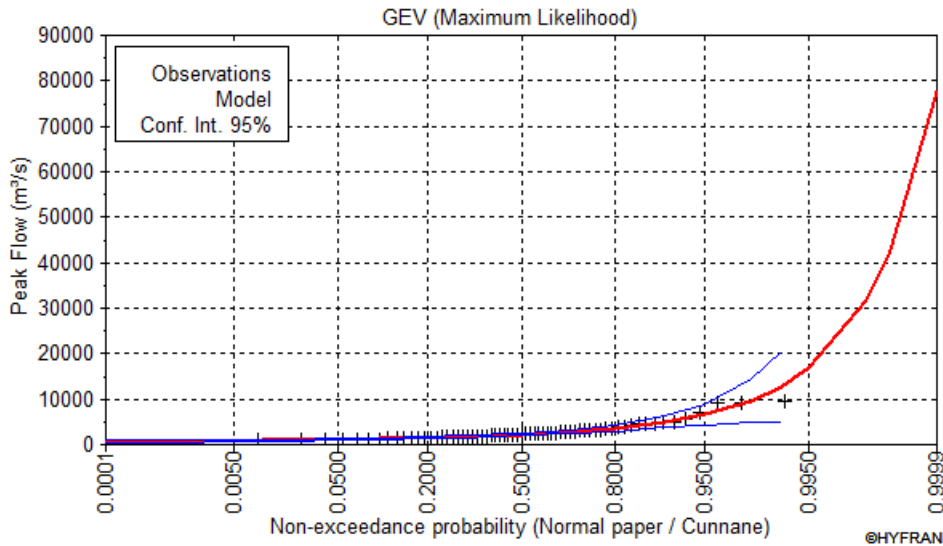
Figure 1-3: GEV (Maximum Likelihood) Probability of Flow Levels

Four distributions were used to estimate the non-exceedance probability of peak flows for different return periods. Figures 1-3 through 1-6 show the GEV (maximum likelihood), 3-parameter lognormal (maximum likelihood), Gumbel (maximum likelihood) and Pearson Type III (conditional maximum likelihood), respectively.

From Figures 1-3 through 1-6, the GEV distribution was chosen to represent the data because it provided reasonable consistency with the input data. Table 1-3 tabulates the different return period flood flows for the various distributions at WSC gauging station 07GJ001.

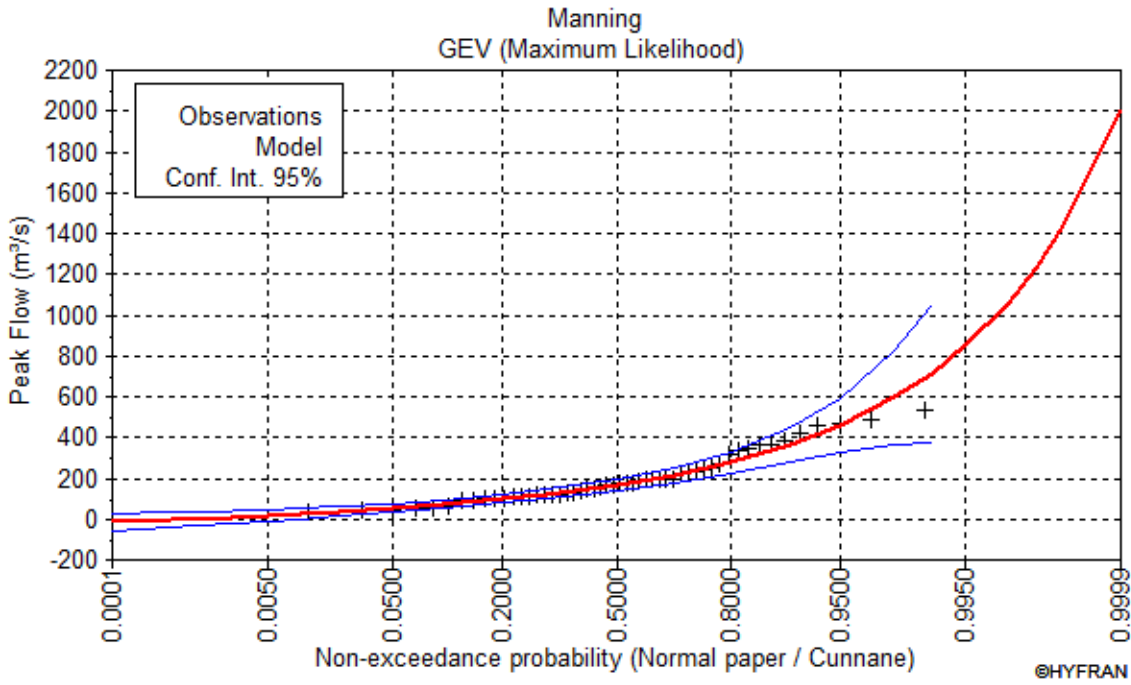
Figure 2-3: GEV (Maximum Likelihood) Probability of Flow Levels

Four distributions were used to estimate the non-exceedance probability of peak flows for different return periods. Figures 2-3 through 2-6 show the GEV (maximum likelihood), 3-parameter lognormal (maximum likelihood) Gumbel (maximum likelihood) and Pearson Type III (maximum likelihood), respectively.

From Figures 2-3 through 2-6, the GEV distribution was chosen to represent the data because it provided reasonable consistency with the input data. Table 2-3 tabulates the different return period flood flows for the various distributions at WSC gauging station 07HC001.

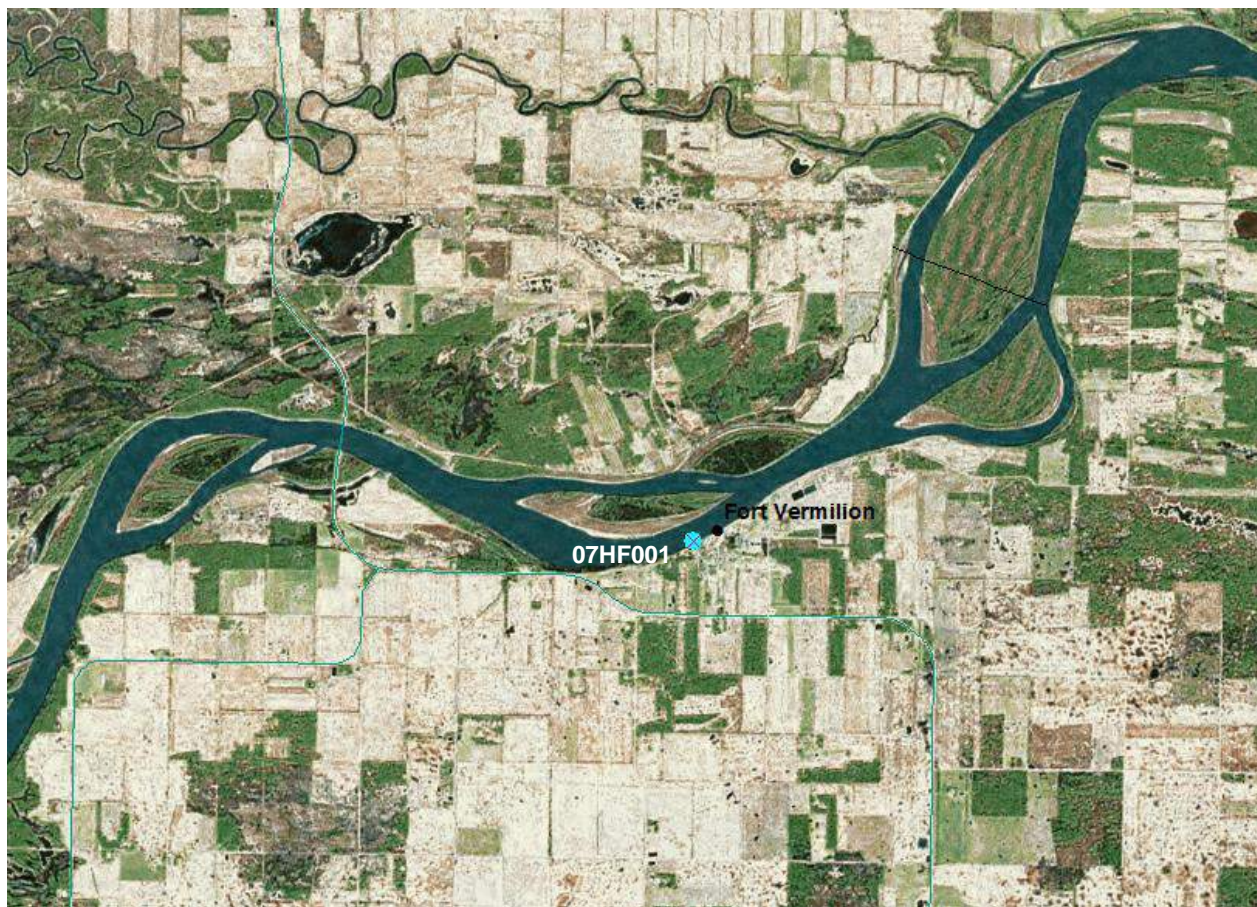
Figure 3-1: Station Location

The Water Survey Canada (WSC) Stream Gauge Station 07HF001 (Peace River at Fort Vermilion) was used for the Flood Frequency Analysis. The station location is shown in Figure 3-1.

The total contributing catchment area to Station 07HF001 is 223,000 km². Table 3-1 details the maximum annual flow data extracted from the WSC gauging station 07HF001.
