Alberta Environment and Sustainable Resource Development

Peace River Basin Flood Mitigation Feasibility Study

Volume 1 of 2

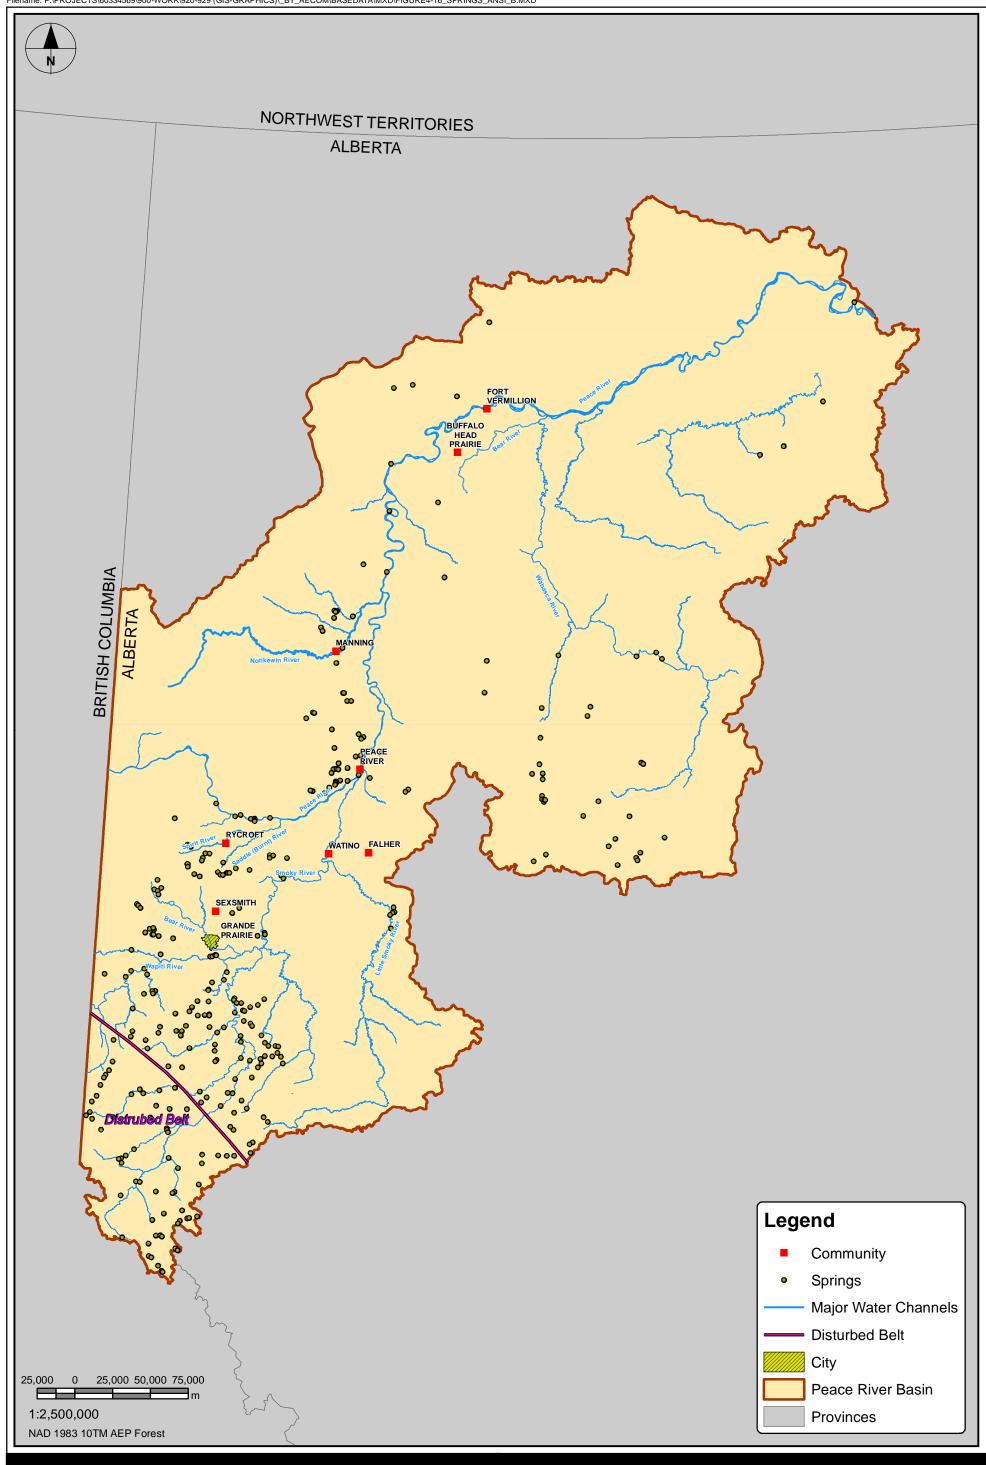
Figure: 4-15

The only bedrock unit with a potential aquifer in the nearby vicinity of the selected areas of interest is the Wapiti aquifer (Figure 4-15). The Wapiti aquifer, composed of the Upper and Lower Wapiti Formations, extends south of Rycroft and Watino and is nearly centred underneath the town of Sexsmith. The Wapiti aquifer is too deep to be an affect during flood events.
